DYNAMIC SCIENCE, INC.
In-Depth Accident Investigation

Case Number DSI-96-AB-003

DYNAMIC SCIENCE, INC.
AIRBAG FIRE INVESTIGATION
CASE NUMBER: DSI-96-AB-003

Case Selection: As the result of an alleged interior electrical wiring fire, the driver's side airbag in a 1994 Dodge pick up truck self deployed. During this deployment the airbag inflator separated from the steering wheel and was projected through the rear wall of the truck cab.

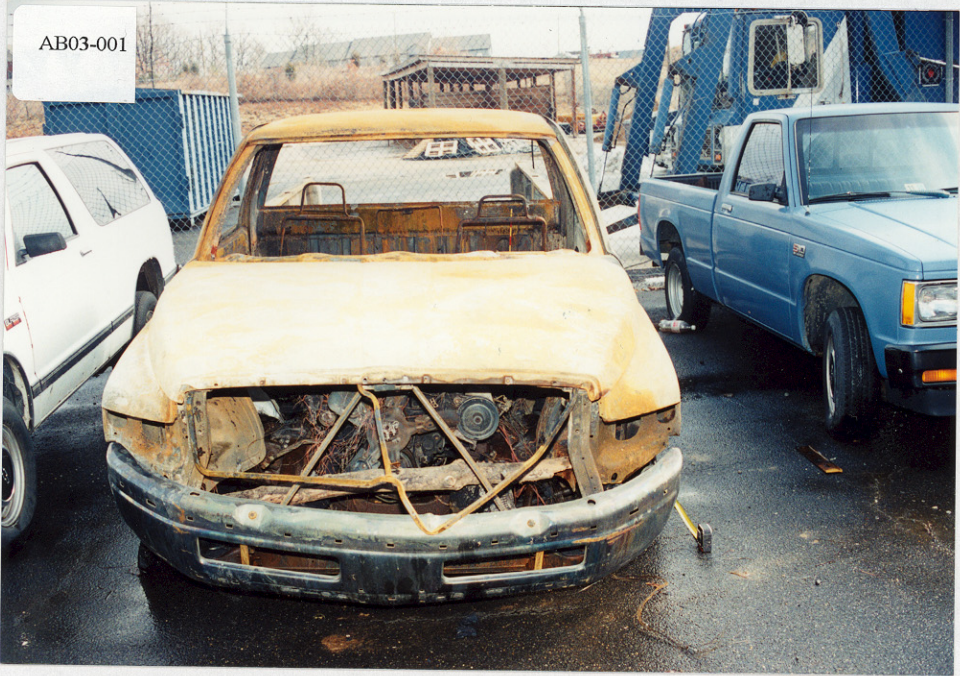
AB03-001

Front - The grille, right and left headlights, and all right and left light components were completely destroyed by direct fire contact. The left front bumper support was heat deformed and the bumper was lowered approximately 5 to 8 cm (2 to 3 in) as a result. The chrome plated bumper was discolored and the black, vinyl-like bumper insert strip was completely destroyed by direct fire contact (Photos 1 and 2). This bumper support deformation, and the lowering of the bumper, may have been the result of earlier investigations (Photo 51). The entire windshield melted and fell inward into the interior of the cab (Photos 1 and 2).

Engine Compartment - The engine coolant radiator and the air conditioning coils were completely melted by direct fire contact (Photos 1 and 2). In addition, the upper and lower radiator supports were deformed by fire and heat. All engine compartment hoses and wiring were destroyed by direct

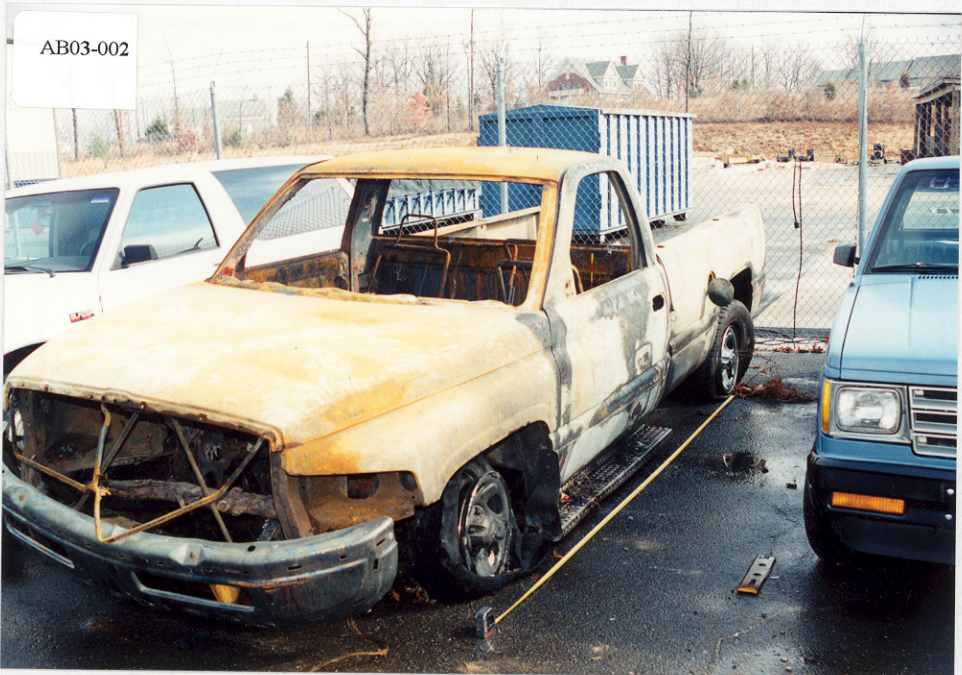
AB03-002

Left Side - The left front fender was burned to metal and was rusting (primer completely burned, temperature above 371° C (700° F). The deflated left front tire had areas of charring from direct flame contact and the chrome plated wheel was discolored by heat (Photo 2). The left front door and cargo box exterior surface showed heat damage, but the primer was gray-white in color indicating a temperature < 232° C (450° F). The black, vinyl-like left side molding was in place, showed no evidence of fire damage, but was soot covered. The gas filler door was open and charred black (Photos 2 and 5). The non-metal gas filler cap could not be located - it appears to have melted, but no residue could be found. The left aluminum running board sustained no fire damage, but several attachment screws were missing and assumed to have been destroyed by heat (Photos 2 and 5). The left door glazing appears to have melted down the exterior of the door - no left side glass residue was found inside the truck (Photos 2 and 5). The left "A" pillar was burned to the metal indicating a temperature greater than 371° C (700° F) (Photos 1 and 2). The deflated left rear tire was charred and the chrome plated wheel was discolored by heat (Photos 2 and 5). There was no apparent heat deformation of the left side plane metal. Black areas on the left side appeared to be charred paint (Photos 5 and 7).

Cab Top - The entire top of the cab was devoid of primer and was rusting. In addition, the top was depressed on the center left side as a result of heat induced temper loss (Fire Department temperature estimate $>483^{\circ}\text{C}$ (900°F)) (Photos 2 and 11).

The hood of the vehicle was rusting from loss of primer, and there was a loss-of-temper depression near the rear edge on the right side (Photos 2 and 4).

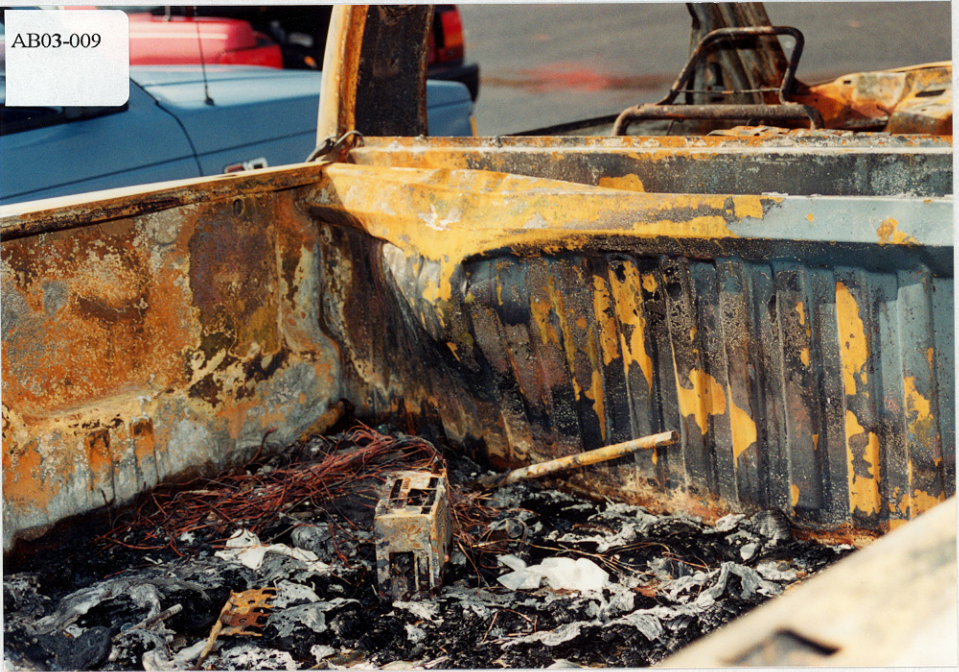
AB03-009

Cargo Box - Residue from the burned fiberglass cap covered the bed of the cargo box (Photos 9, 54 and 55). The right side interior wall sustained heat damage, but the gray-white primer remained indicating a temperature in the area of $<232^{\circ}\text{C}$ (450°F) (Photos 5 and 7). The left side and front walls sustained fire damage and were rusting indicating a temperature $>371^{\circ}\text{C}$ (700°F) in these areas (Photos 6 and 8).

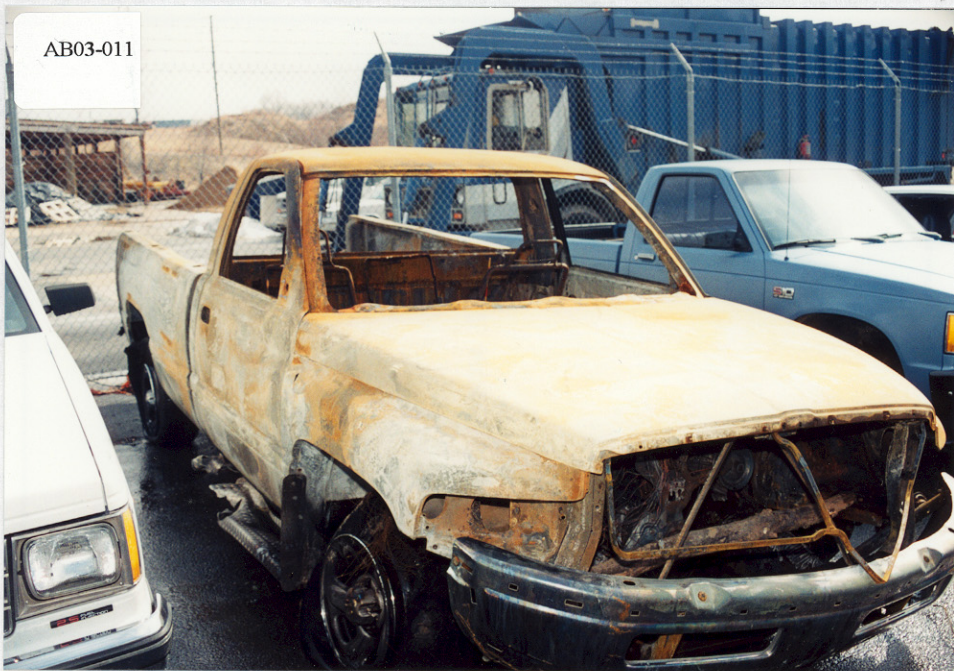
AB03-011

Right Side - The right front fender, door, "A" pillar and forward quarter of the cargo box evidenced fire damaged primer that indicates temperatures ranged from $>232^{\circ}\text{C}$ (450°F) to $>371^{\circ}\text{C}$ (700°F) (Photos 8 and 11). The right rear tire, and chrome wheel, were soot covered, but showed no charring or discoloration. The right rear tire was not deflated (Photo 11). The black, vinyl-like right side molding was completely destroyed and no residue could be found (Photos 8 and 11). The rear portion of the aluminum running board was melted, and deformed, by apparent direct flame contact (Photos 8 and 11). The glazing in the right door melted and fell into the interior of the cab. The right front tire was deflated and charred. The chrome plated wheel was discolored by heat (Photo 11).

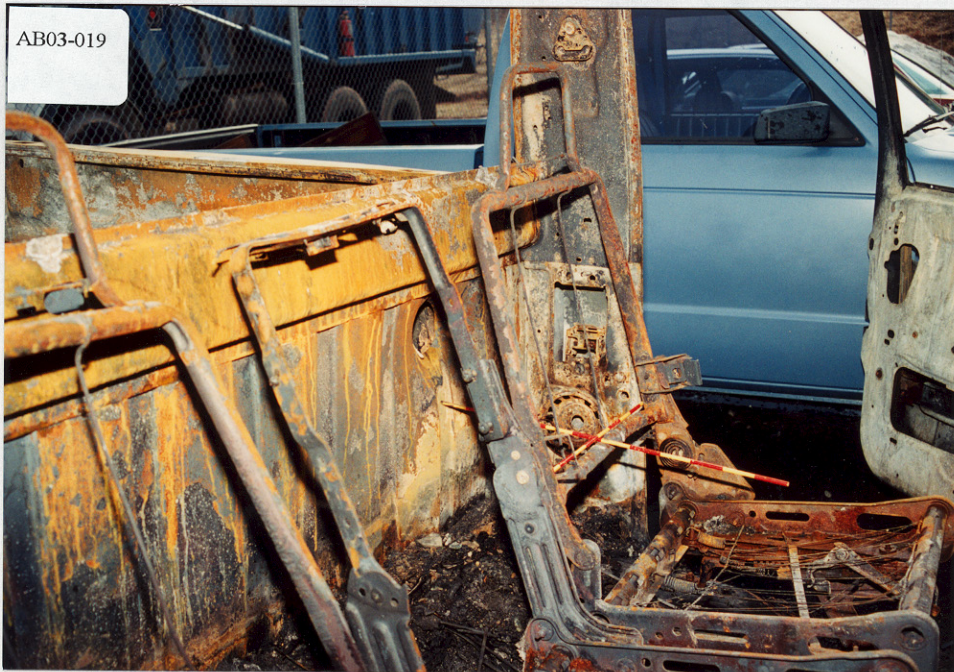
AB03-019

Interior - The vehicle interior was completely gutted with all fabric, vinyl and plastic trim being completely burned to unidentifiable residue left on the floor of the vehicle. The interior burn patterns were relatively uniform with the right side and entire instrument panel sustaining the severest damage (Photos 21 and 22). In these areas, the temperatures are estimated to have been well above 371° C (700° F) with metal deformation and the melting of attachment screws on the left instrument panel and steering column. The back wall of the cab, and the left front seat sustained estimated temperatures ranging from 232° C (450° F) to >371° C (700° F) (Photos 14-20). The interior trim panel of the left front door was completely burned, but the metal door surface retained the gray/white primer indicating the door was subject to temperatures estimated to have been <232° C (450° F). The condition of this door indicates that it was, in fact, open during the course of this fire (Photos 19 and 20).

The left rear wall of the truck cab contained an 8.5 cm (3.3) diameter hole. This hole was located, on center, 32.5 cm (12.8 in) right of the left door latch pillar, 35.6 cm (14 in) above the rear floor and 36.8 cm (14.5 in) below the lower edge of the rear window. This hole, made by the airbag inflator, completely pierced the rear wall and was in direct line with the cargo box deformation (Photos 13-20).

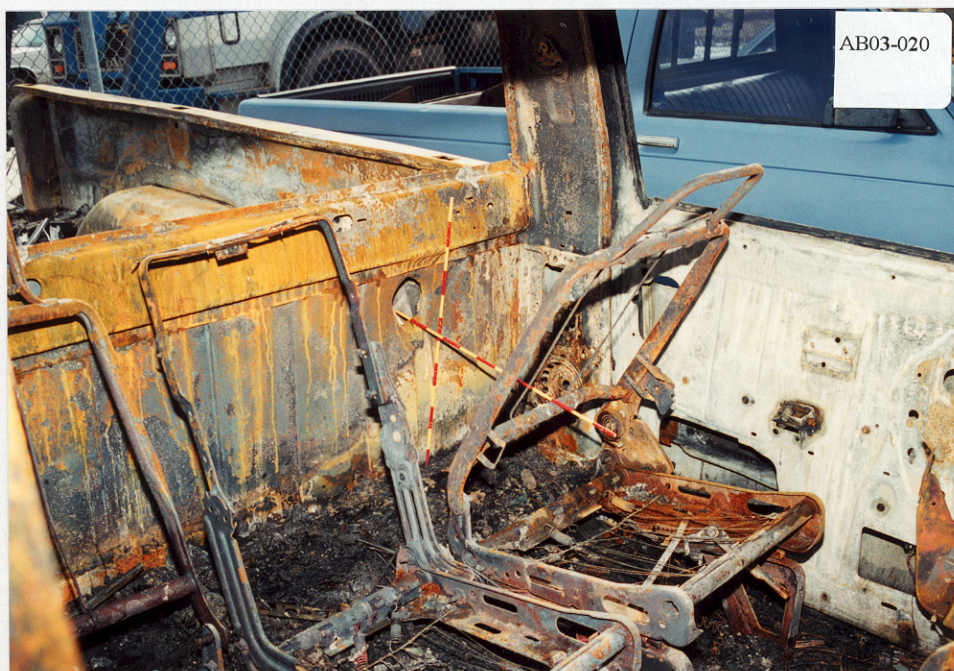
AB03-020

5. Based on the relatively flat trajectory of the diffuser, it appears the steering wheel/steering column had dropped downward approximately 25 cm (10 in) at the time the airbag began to inflate (Photo 20).

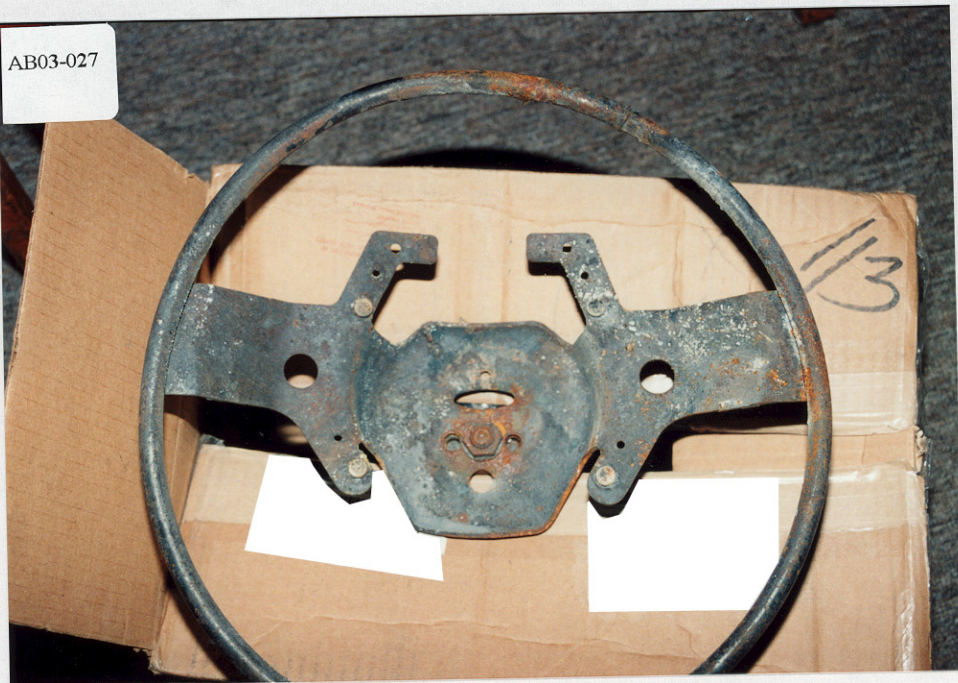
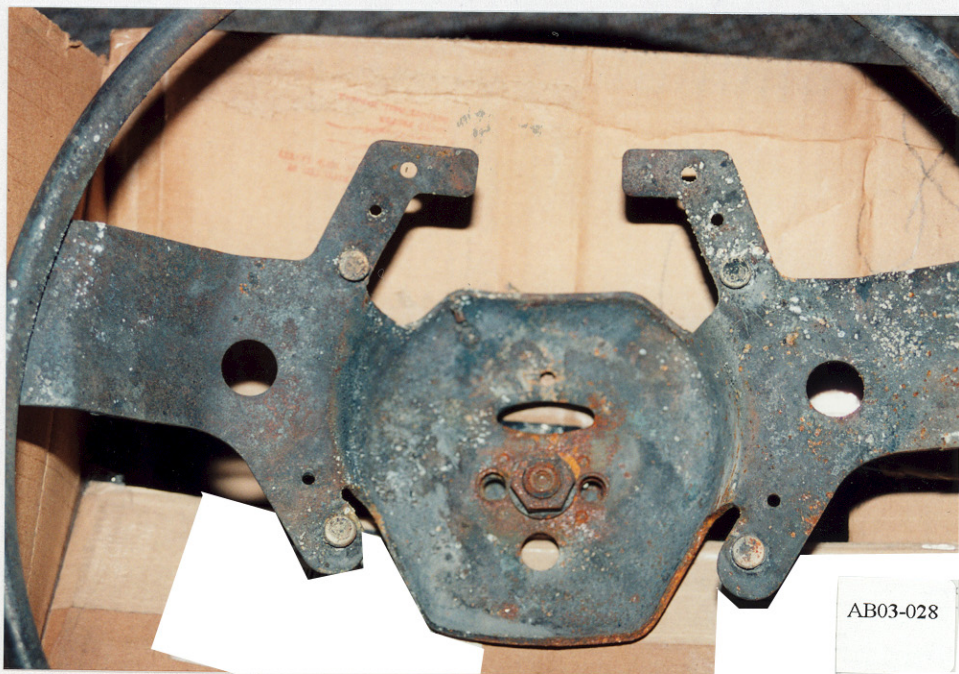
AB03-027

7. The steering wheel's airbag module attachment point was deformed (Photos 26-31).
8. It appears that the diffuser and combustion chamber were forcibly separated from the chamber cover (Photos 34-37 and 47-50).

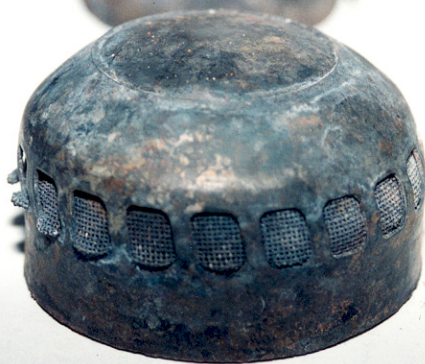
AB03-044

1. The diffuser and combustion chamber were found between the back wall of the truck cab and the front wall of the cargo box. Remnants of the final filter were attached to the diffuser (Photos 44, 45, 49 and 50).
2. The top of the diffuser was convex from internal pressure (Photos 44-46).
